Massachusetts Bay Transportation Authority: Climate Change Vulnerability Assessment for the Blue Line (Draft)

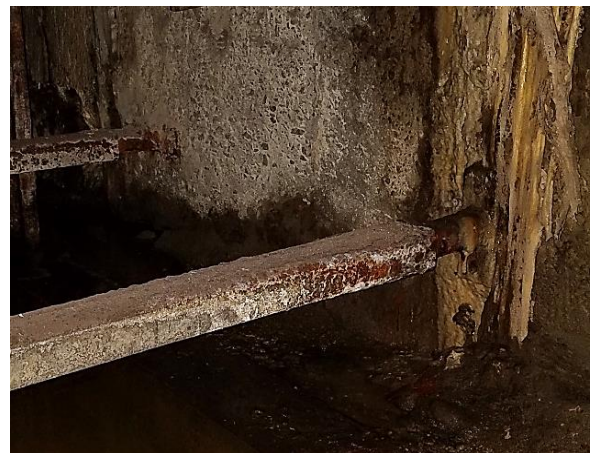
Exhibit 7. Visible Evidence of Exposure to Saltwater at Aquarium Station.

The MBTA's Engineering and Maintenance (E&M) staff routinely work to limit water's entry into the station, but keeping it out completely has not yet been possible. For example, the E&M staff has designed a temporary system for diverting saltwater away from the third rail just inside the tunnel at Aquarium Station, as shown in Exhibit 9 (wood panels diverting the leak are circled). This type of solution addresses the problem successfully in the short-term, but will ultimately require a longer-term solution that incorporates increasing volumes of water due to rising sea-level. The amount of water increases with the height of the tide, as the groundwater is tidally-influenced.

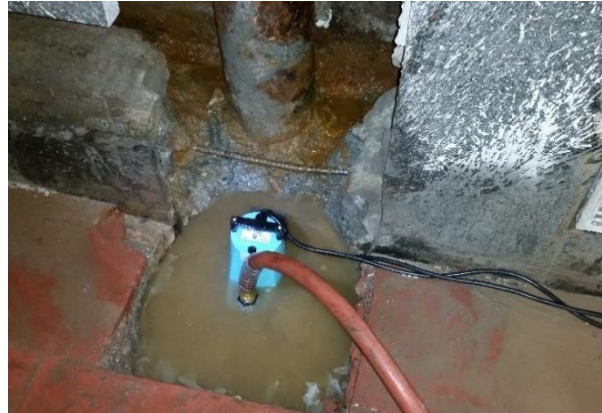
Exhibit 8. Drainage Trough and Pump at Aquarium Station

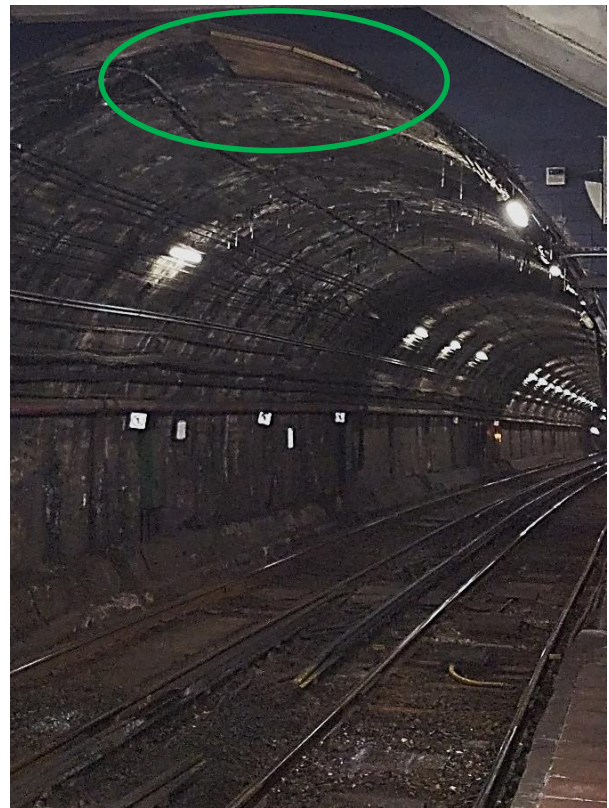
Exhibit 9. Temporary Diversion for Water Entering Tunnel at Aquarium Station.

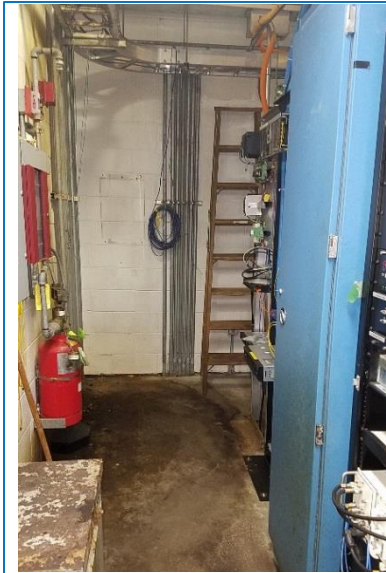
Communications Room, Suffolk Downs Station

Exhibit 10. Example Images of Station Assets Potentially Exposed to Coastal Flooding

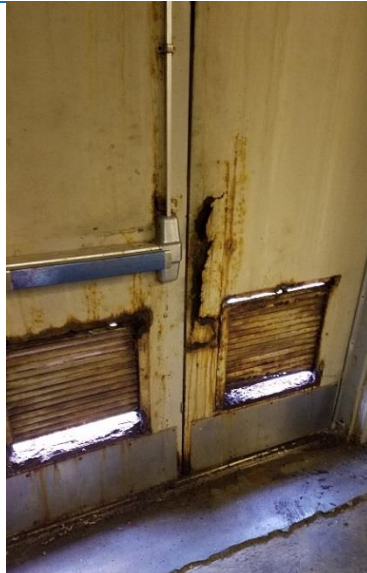
Generator Room Exterior Door, Suffolk Downs Station

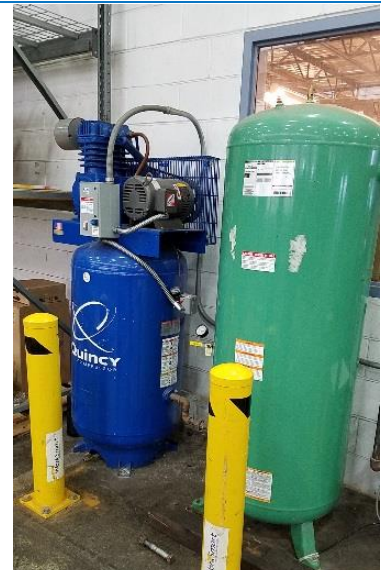
Hydraulics Equipment, Orient Heights Maintenance and Storage Facility

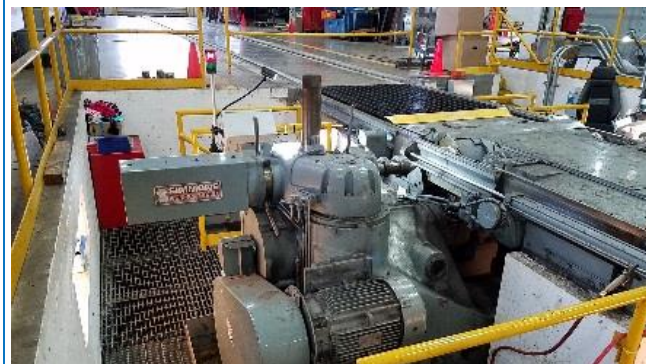
Wheel Truing Machine (Below Grade), Orient Heights Maintenance and Storage Facility

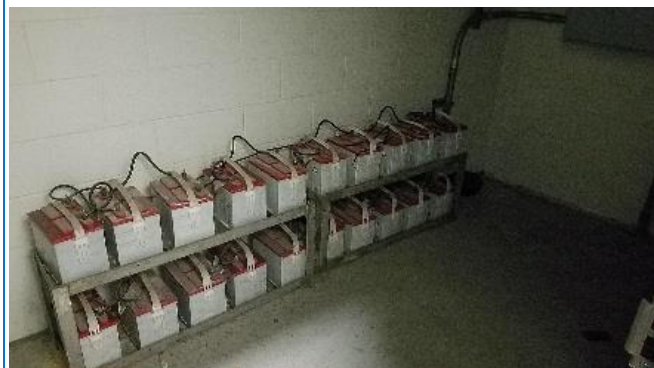
Emergency Battery System Packs, Wood Island Station

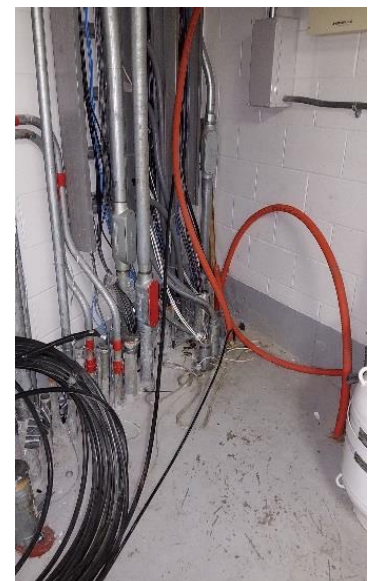
Communications Cables, Airport Station

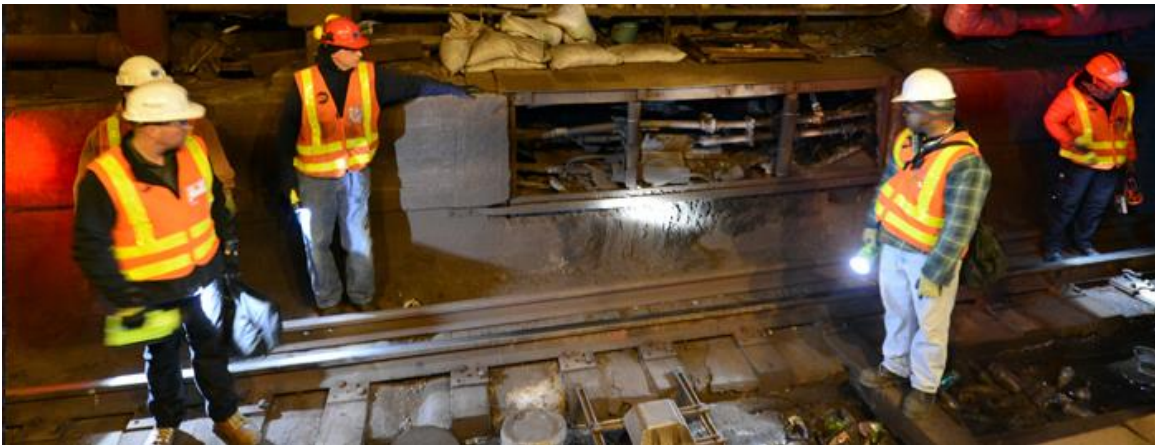
Of the climate stressors analyzed in this vulnerability assessment, the sensitivities of transportation assets to sea-level rise and storm surge would likely be the most consequential for the MBTA. Exposure to salt water can have lasting impacts beyond the inundation event itself due to the long-term “latent” damage to metal infrastructure (e.g., tracks or third rail) and electrical systems from corrosive seawater. Any metals exposed to salt water are at risk of corrosion, even if the actual inundation is a short-lived event. To illustrate, inundation of New York’s subways tunnels with salt water as a result of 2012’s Superstorm Sandy led to extensive corrosive damage. The Canarsie Tunnel, shown in Exhibit 12, must be entirely reconstructed as a result of the damage left behind by the millions of gallons of salt water that entered the tunnel. Both tubes in the tunnel will be closed for 18 months, starting in 2019 (MTA 2016).

Exhibit 12. Corrosion in New York’s Canarsie Tunnel after Flooding from Superstorm Sandy (Source: MTA 2016)
