Massachusetts Bay
Transportation Authority

Rail Transit Tunnel Inspection Manual

February 2019 Rev. 0

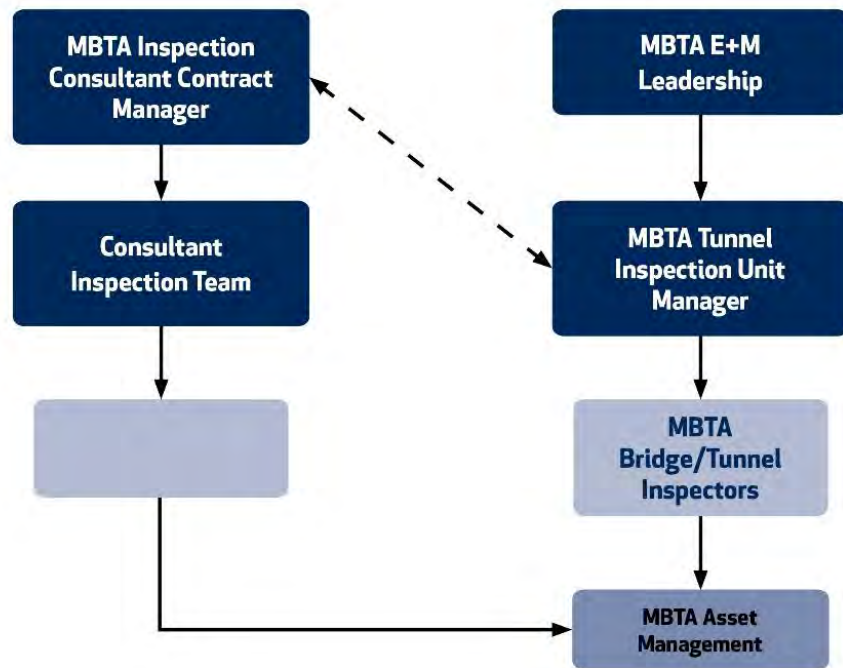
MBTA’s inspection unit structure can be described in the organization figure 1.4-1.

Figure 1.4-1: MBTA Tunnel Inspection Unit Structure

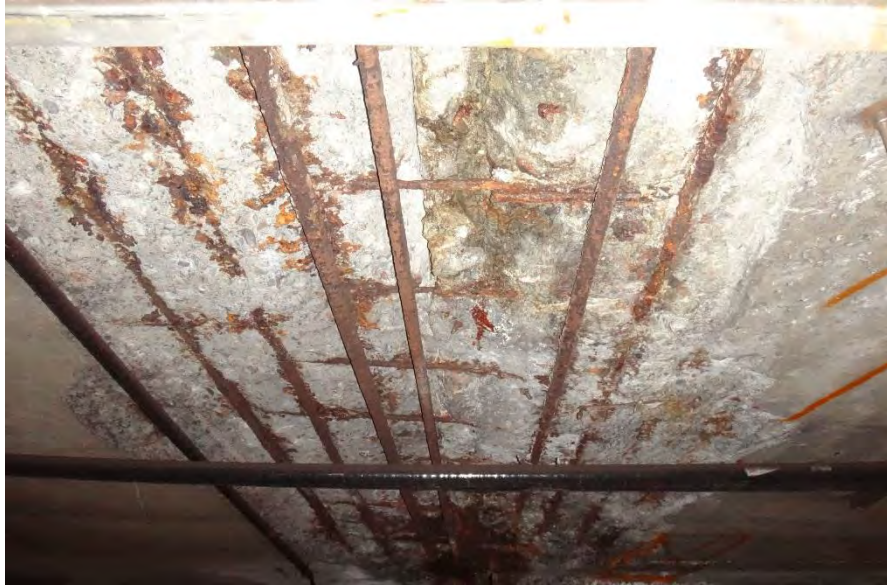
- a) Spalls: Spalls are visually apparent along the concrete surfaces of the tunnel. Spalls are roughly circular or oval depressions caused by the separation and subsequent removal of a portion of the concrete revealing a fracture that is roughly parallel, or slightly inclined, to the surface. Often, portions of the main reinforcing steel or prestressing strands are exposed and exhibit varying degrees of corrosion and/or section loss if not epoxy coated.

Spalls should be documented in length and width or length and height (depending on the plane on which the spall is found) with a corresponding depth and should be classified into different defect codes as discussed in Section 7. The presence and condition of exposed reinforcement should also be documented, as this can affect the condition state coding.

Figure 6.2.1-1 Concrete Deficiency: Spall with Exposed Reinforcing Steel

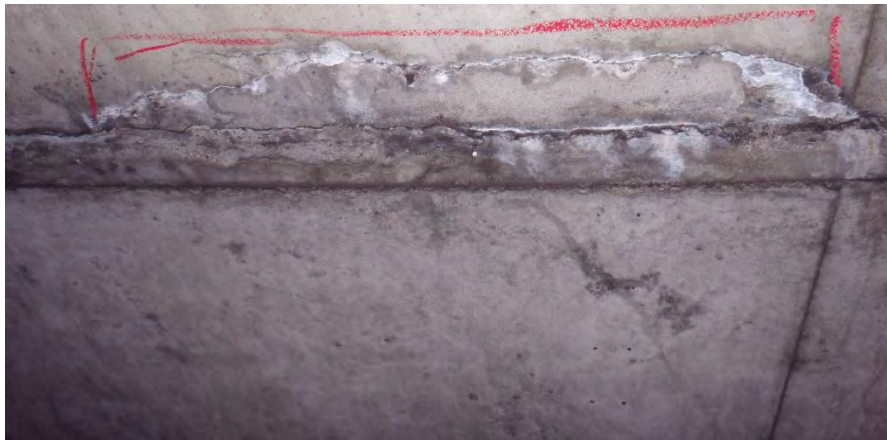
- b) Delamination (sometimes referred to as incipient spalls): A delaminated area of concrete is one that produces a hollow sound when struck by a hammer. Delaminated areas are more difficult to detect than spalls since they are laminar to the surface of the concrete. Areas of delamination that are visibly apparent due to the presence of cracks (such as map or pattern cracks that may encompass the full perimeter of the area with noticeable distress, movement, or separation between adjacent surfaces) are often referred to as incipient spalls. Incipient spalls are considered critical findings if they present a safety issue and should be dealt with immediately in accordance with the provisions outlined in Section 4.7.

Figure 6.2.1-2 Concrete Deficiency: Delamination

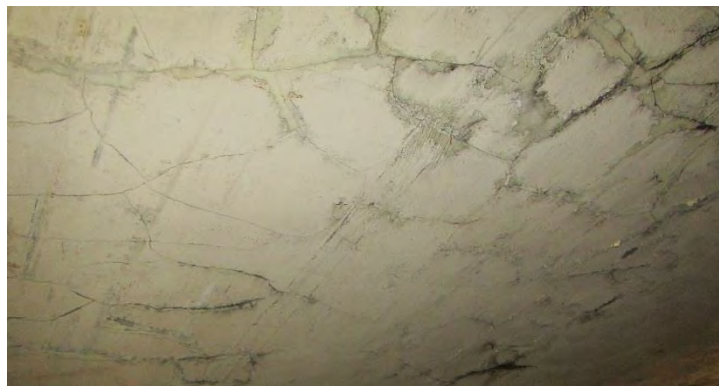
- Transverse Cracks — Cracks that are mostly straight and roughly perpendicular to the span of the member.
- Longitudinal Cracks — Cracks that are mostly straight and roughly parallel to the span of the member.
- Horizontal Cracks — Cracks that are oriented horizontally and generally occur in walls or other vertical surfaces.
- Vertical Cracks — Cracks that are oriented vertically and generally occur in walls or other vertical surfaces.
- Diagonal Cracks — Cracks that are roughly inclined at a 45-degree angle. When found along the vertical face of beams at or near a support, they signify a potentially insufficient amount or an improper placement of shear reinforcement.
- Pattern or Map Cracks — Cracks that are interconnected, vary in size, and form networks like that of spider cracking observed in dry areas. They vary in width from barely visible fine cracks to well-defined openings.

Figure 6.2.1-3 Concrete Deficiency: Map Cracks

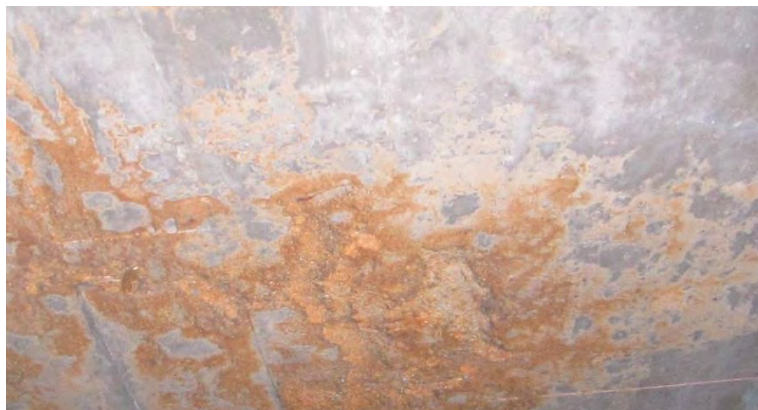
- Random Cracks — Meandering irregular cracks on the surface of concrete. They have no form and do not logically fall into any of the classifications described above.
- d) Rust Staining: Rust staining is a visibly apparent discoloration of the concrete's surface caused by dissolved materials passing through cracks and being deposited on the surface when the water emerges and evaporates. Rust staining is typically brown or red

It is not uncommon for rust staining to be the result of corrosion of ancillary metal items or brackets that are supported from the concrete element. This type of rust staining is not structural and is typically superficial. The inspector should clearly make a distinction between the two.

Figure 6.2.1-4 Concrete Deficiency: Rust Staining

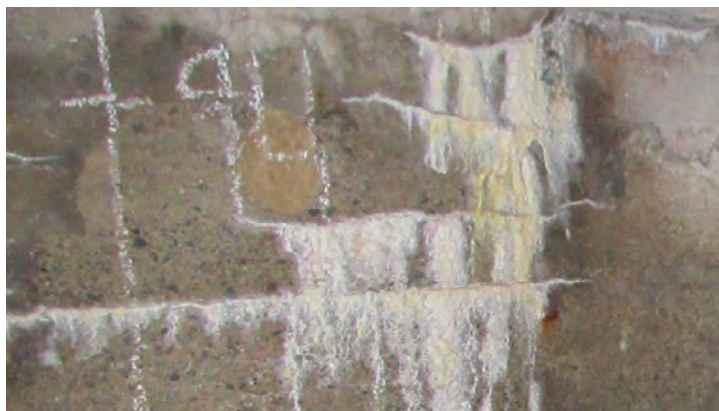
- e) Efflorescence: Efflorescence, similar to rust staining, is a visibly apparent discoloration of the surface of the concrete caused by a combination of calcium carbonate leached out of the cement paste and other recrystallized carbonate and chloride compounds that form on the concrete surface.

Figure 6.2.1-5 Concrete Deficiency: Efflorescence

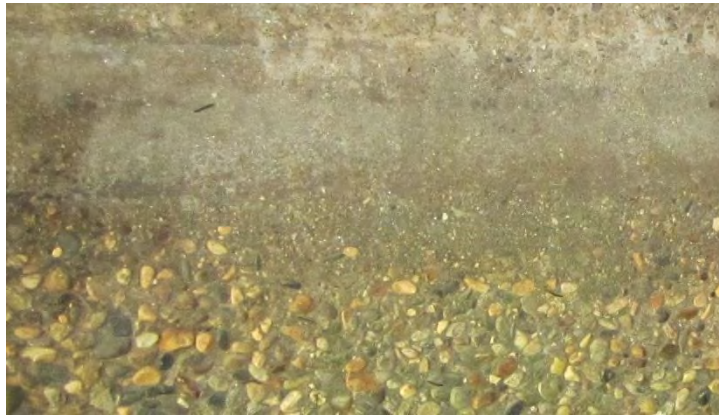
- f) **Wetness:** Wetness is visibly apparent and typically occurs on regions of the concrete liner (walls, roof, or invert slab) where water is visible penetrating either through existing cracks or through construction/expansion joints. The type of structure and the method of construction may greatly contribute to the likelihood of encountering wetness within a segment of tunnel.
- g) **Scaling:** Scaling is the visibly apparent gradual and continuing loss of surface mortar and aggregate. It should be documented noting an associated length/height or height/width with corresponding depth. Various degrees of scaling are discussed in Section 7.

Figure 6.2.1-6 Concrete Deficiency: Scaling

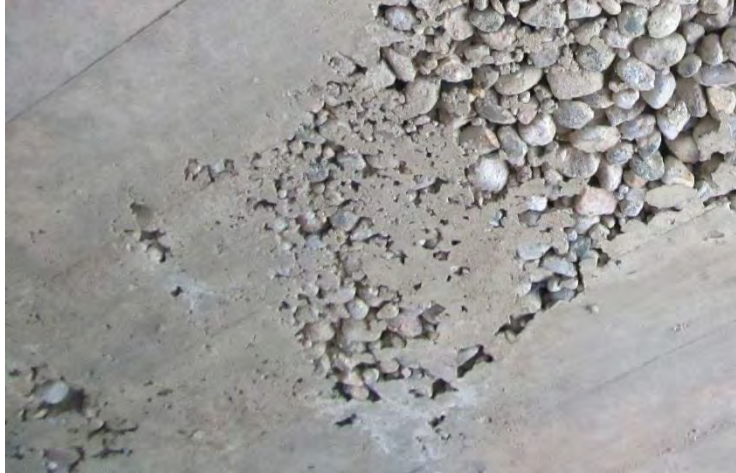
- i) **Mudballs:** Mudballs are visibly apparent small holes that are left in the surface by the dissolution of clay balls or soft shale particles. Mudballs should be documented and classified in a manner similar to that used for pop-outs.
- j) **Honeycomb:** Honeycomb represents areas of typically small voids within concrete and represents construction defects that result from insufficient vibration of concrete. When honeycomb is at the surface, it is visible as small irregular-shaped voids, often exposing aggregate or other embedded items.

Figure 6.2.1-7 Concrete Deficiency: Honeycomb

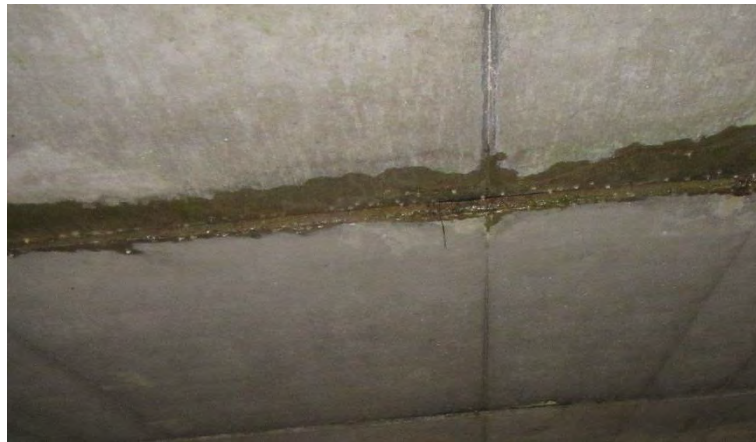
- Differential settlement that may have occurred along expansion joints or in transition areas of the tunnel, such as at the interface between an arch section and a box section or between a tunnel section and a station.

Figure 6.2.1-8 Concrete Deficiency: Differential Settlement

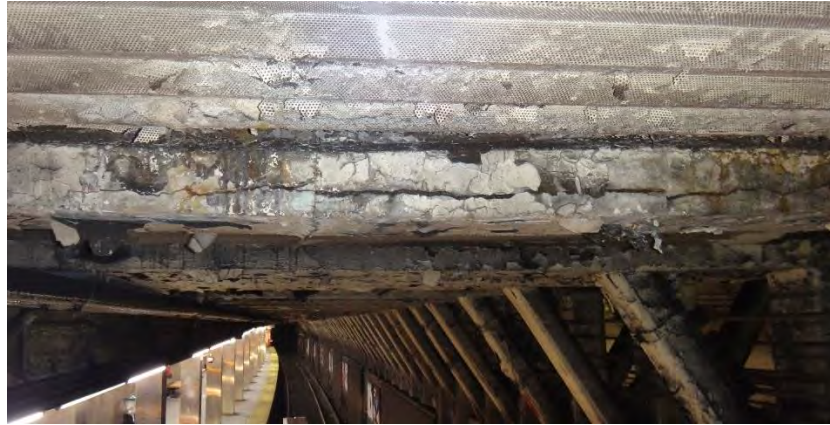
- Incipient spalls at concrete-encased steel beams, particularly where longitudinal separation cracks are visually apparent along the flange of the beam or where active leaks are readily apparent.

Figure 6.2.1-9 Concrete Deficiency: Incipient Spall at Concrete Encased Steel Beam

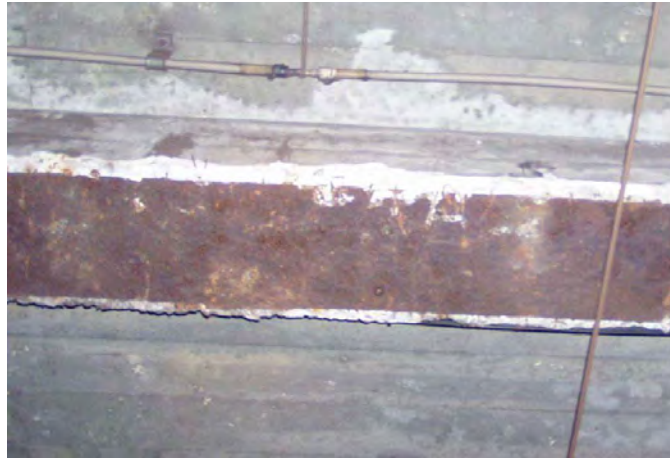
- Minor — A light, loose formation of corrosion that easily brushes off the surface.

Figure 6.2.2-1 Steel Deficiency: Light Corrosion

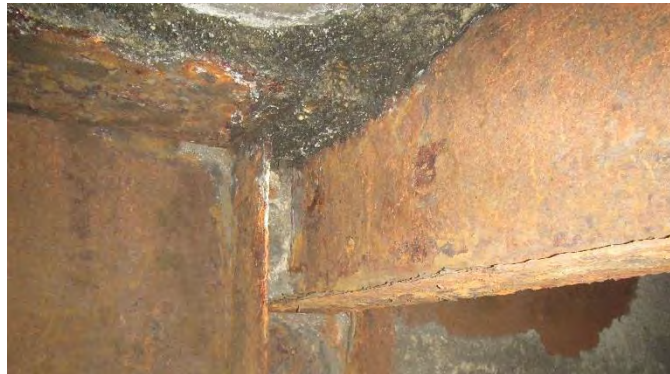
- Moderate — A looser corrosion formation with scales or flakes forming. Definite areas of corrosion are discernible.

Figure 6.2.2-2 Steel Deficiency: Moderate Corrosion

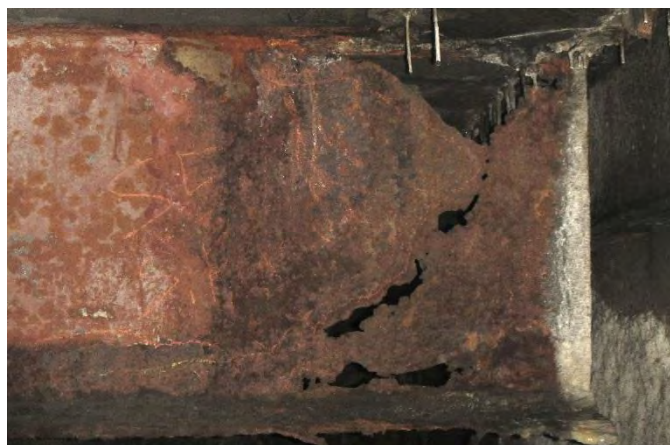
- Severe — A heavy, stratified corrosion or corrosion scale with pitting of the metal surface. This corrosion condition eventually culminates in loss of steel section and generally occurs where there is water infiltration.

Figure 6.2.2-3 Steel Deficiency: Severe Corrosion

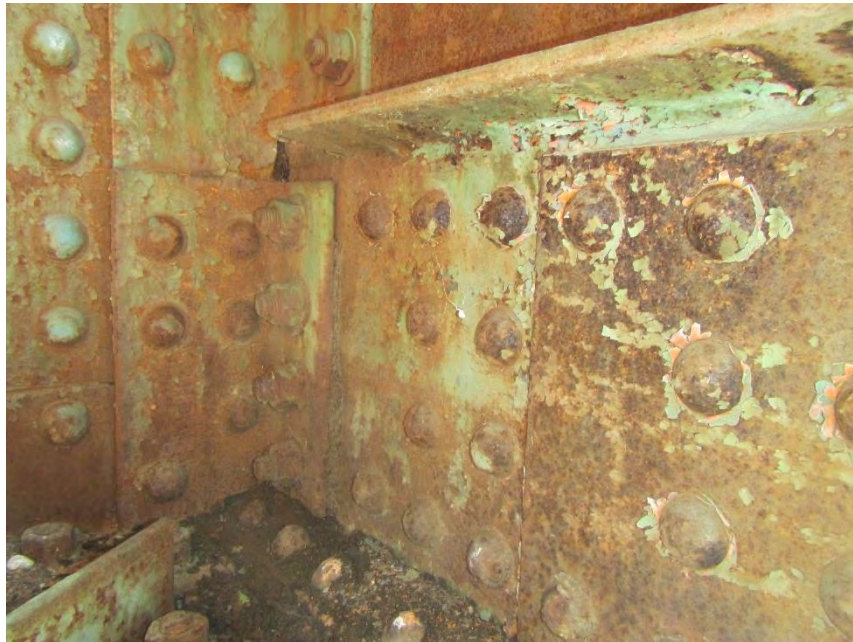
- b) Cracks: Cracks in the steel may vary from hairline thickness to a width sufficient to transmit light through the member. Any type of crack in a primary steel member is serious and should be reported at once. Look for cracks radiating from problematic details such as cuts, notches, and weldments. All cracks in the steel will be classified as severe.
- c) Connection: Steel connections may consist of riveted, bolted, or welded connections. For riveted or bolted connections, individual fasteners may be missing, loose, or corroded. Welded connections should be checked for cracks.

Figure 6.2.2-4 Steel Deficiency: Connection (Light Corrosion)

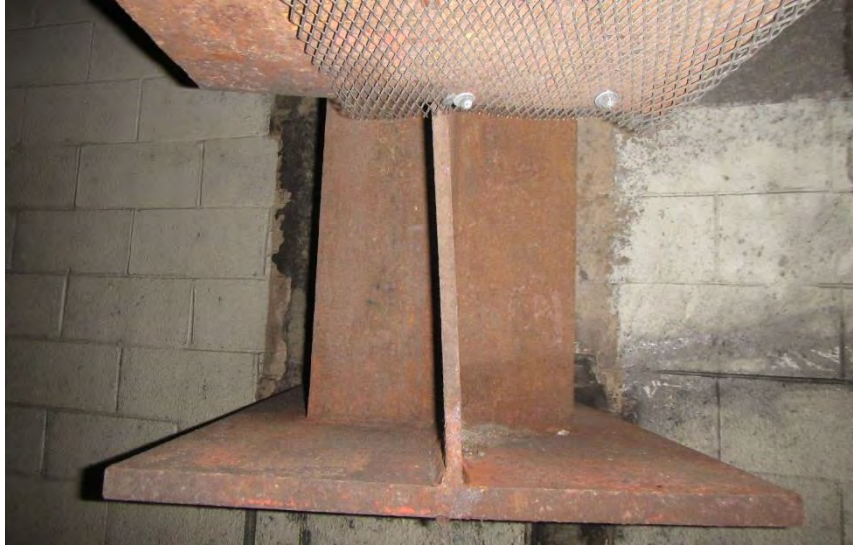
- d) Distortion: Distortion develops primarily because of damage arising from thermal strain, overload, or added load conditions. Erection or collision damage may also cause buckles, kinks, and cuts.

Figure 6.2.2-5 Steel Deficiency: Distortion

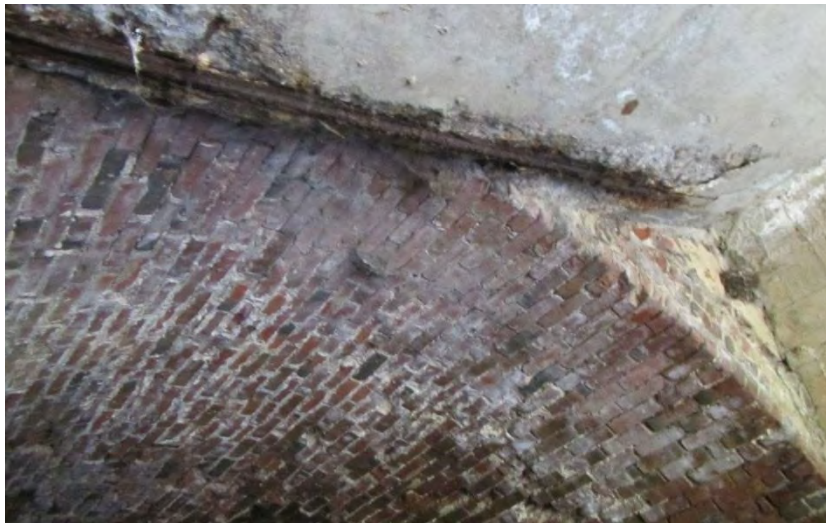
- a) Efflorescence, Rust Staining: Efflorescence and rust staining are defined in Section 6.2.1 d) and e) above. The presence of either in masonry structures or facades typically manifests through cracked or defective mortar joints. The presence of rust staining would also likely indicate that the reinforcing steel behind the masonry facing is corroding.
- b) Mortar Breakdown: Mortar should be checked for its soundness and bonding to the masonry units. It is important to note cracked and missing mortar, especially the depth and extent of missing mortar.

Figure 6.2.3-1 Masonry Deficiency: Mortar Breakdown and Efflorescence

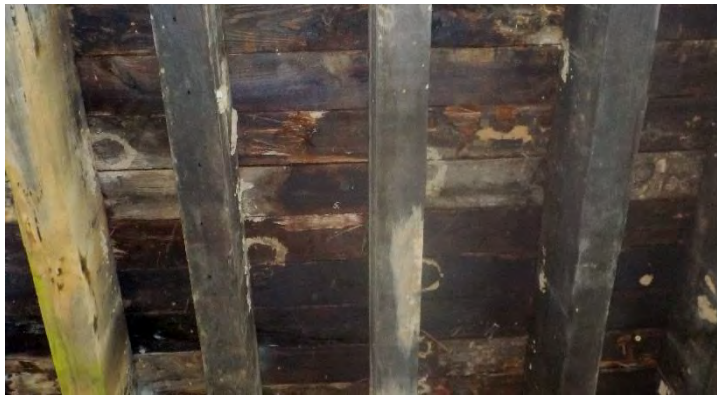
- a) Decay or Rot: Decay is the primary cause of timber deterioration. It is produced by living fungi that feed on the cell walls of timber members. Decay occurs in areas where moisture is present and causes a black, brown, or white discoloration on the surface. This leads to soft wood and section loss, which should be investigated and documented.

Figure 6.2.4-1 Timber Deficiency: Decay or Rot

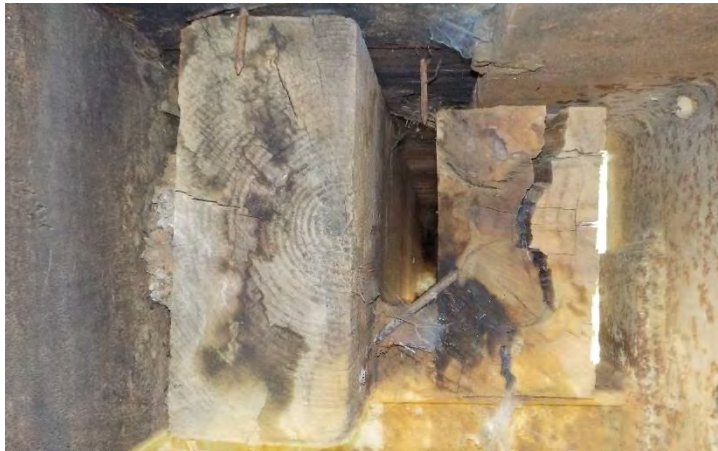
- b) Voids: Voids in this context refer to the presence of voids in the earth material behind lagging and not voids within the timber itself. These can sometimes be seen between the planks or detected by probing with a wire.
- c) Cracks, Splits, Checks: Cracks in timber members are classified as checks, which penetrate to a partial depth, and splits, which penetrate completely through the member.

The extent and location of both should be identified, with special emphasis on splits within timber beams.

Figure 6.2.4-2 Timber Deficiency: Cracks and Splits

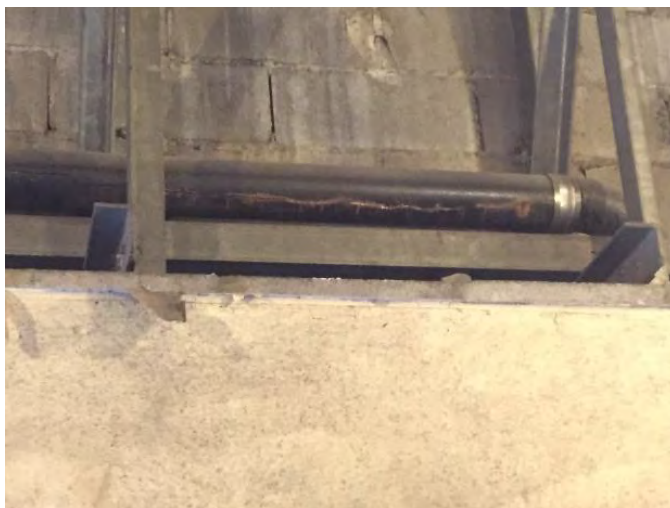
- Clogs
- Cracked pipes (see photo below for an example of deterioration)

Figure 6.3.1-1 Drain System Deficiency: Cracked Pipe

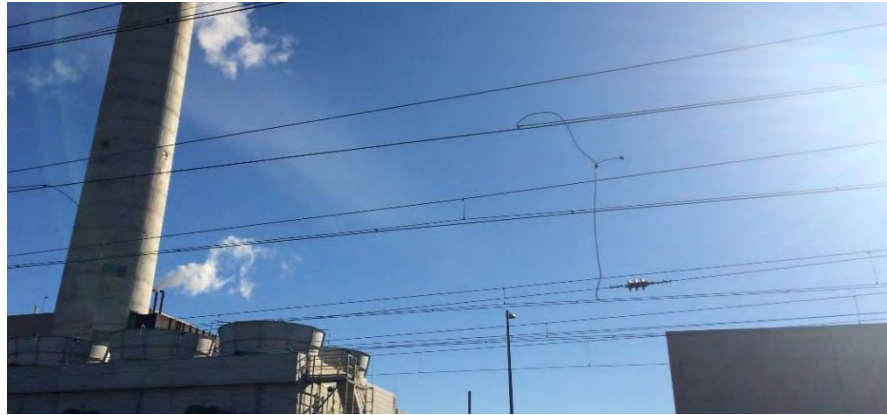
- a) Power/Cable Conductor
 - Broken cables/conductors — Cables and conductors can break apart during extreme changes in temperature and from fatigue, progressive burning, and improper application.

Figure 6.6.2-1 Power Asset Deficiency: Fatigue Break of a Conductor

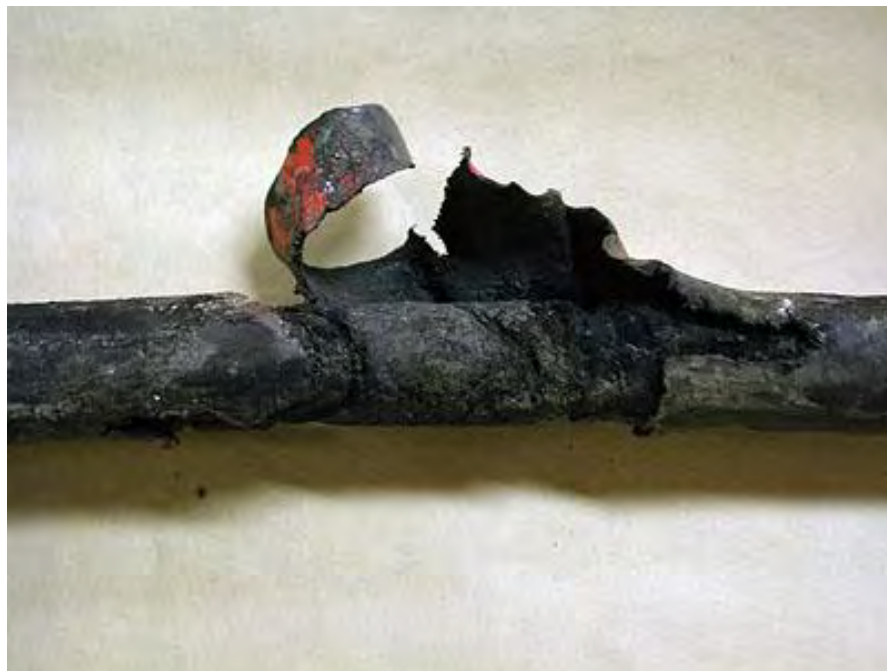
- Signs of arcing — The protective cover or sheath can be damaged from the outside in by arcing. This type of damage can appear as burn marks on the cable's sheath or the sheath being completely melted through, as seen in the photo below.

Figure 6.6.2-2 Power Asset Deficiency: Signs of Arcing on Cable

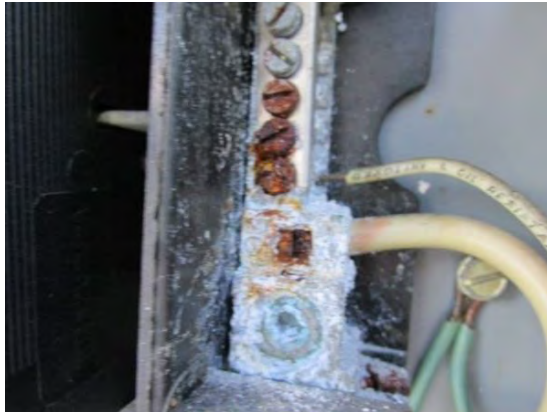
- Corrosion — Corrosion can occur at the end of power cables on the taps. Corrosion can be caused by stray current, improper tightening, exposure to salt water, etc. The following photograph illustrates an example of a corroded tap.

Figure 6.6.2-3 Power Asset Deficiency: Corrosion

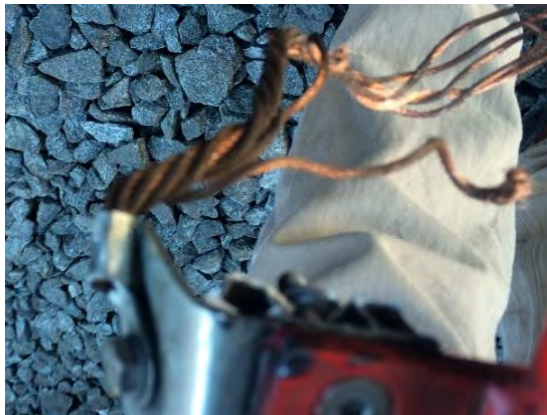
- Frayed conductors — Stranded conductors can come apart.

Figure 6.6.2-4 Power Asset Deficiency: Frayed Conductor

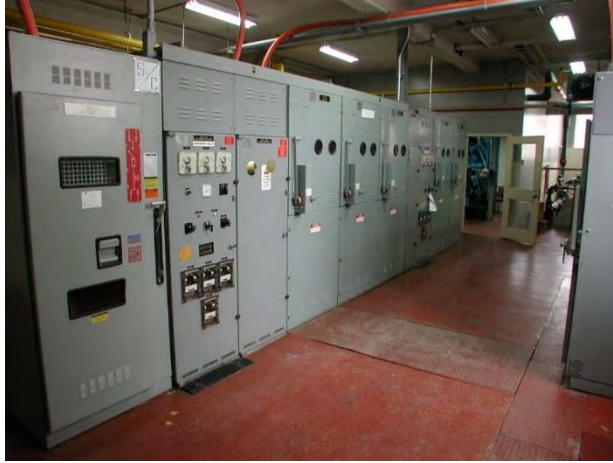
- b) Substation Deficiencies
- Damage to enclosure — Take notice of any abnormal conditions on the transformer enclosure. Damage could be in the form of vandalism, broken hinges or latches, burn marks, etc.

Figure 6.6.2-6 Typical Electrical Room

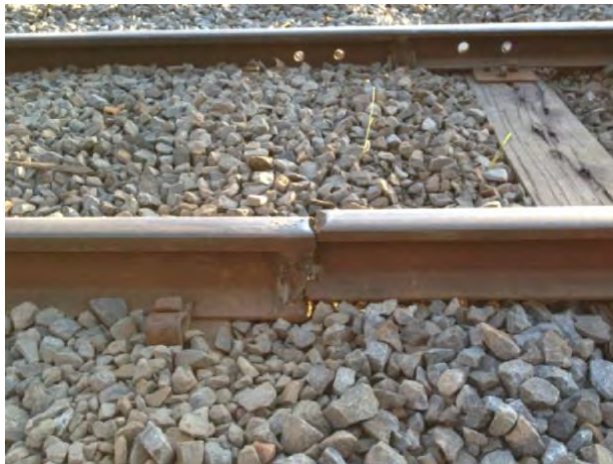
Figure 6.6.3-1 Track Asset Deficiency: Broken Rail

- a) Broken Rail: A rail can be cracked through with a transverse fracture that goes from the top to the bottom of the rail. Such cracks will affect the signal system and power return. Emergency clamps can be used to allow trains to pass until the broken rail section can be replaced with a new rail or joint. Other external cracks such as fissures and fractures are visible to the eye. Internal failures include splits, piping, fissures, cracks, or separations inside the rail and can only be found using tests such as ultrasounds or x-rays. Hence, the visual inspection can only pick up defects visible on the outside of the rail, not internal defects.

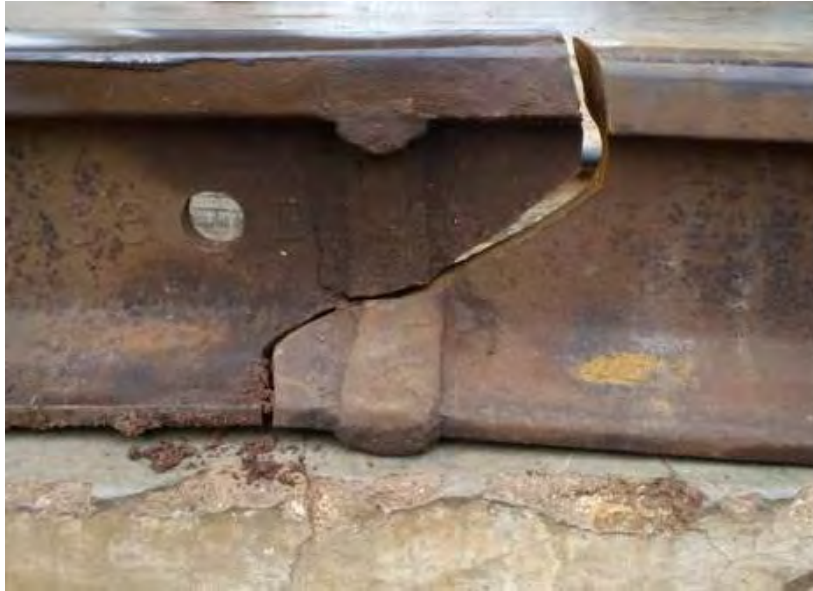
Figure 6.6.3-2 Track Asset Deficiency: Weld Failure

- b) **Weld Failures:** Weld failures are separations at the weld, be it a shop weld or a field weld. Field weld failures are usually identified using x-ray or ultrasound testing and may not be visible on the outside of the rail until failure of the rail has occurred. See the photograph below for a visual aid to determining deterioration.

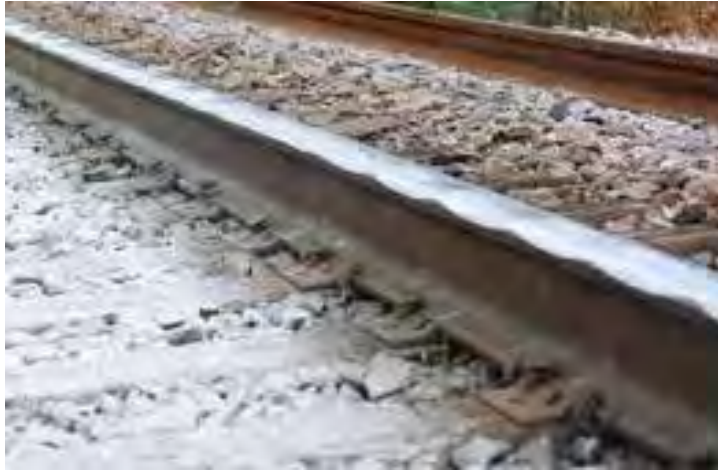
Figure 6.6.3-5 Track Asset Deficiency: Corrugation

- e) Corrugation: Corrugation, or “washboarding,” occurs on the rail head due to factors that include wheel slippage. It creates a wave pattern on the rail head that can generate noise and vibration. It is observed through visual inspection. Corrugation can be ground away with a rail grinder, or the rail can be replaced.

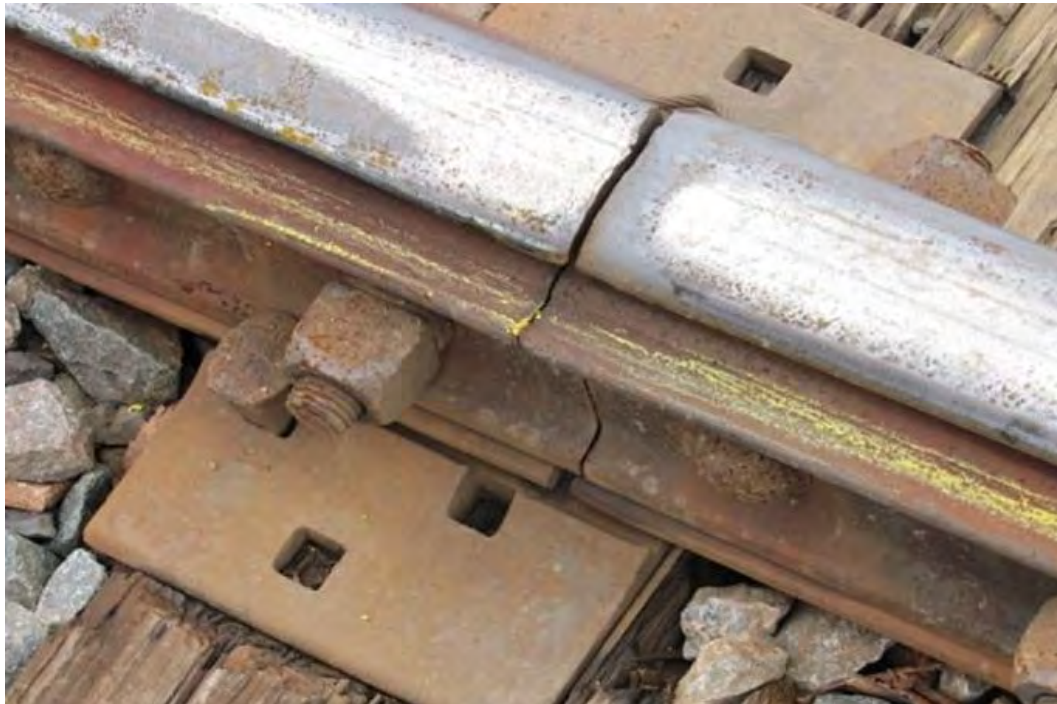
Figure 6.6.3-6 Track Asset Deficiency: Joint Defect

- f) Joint Defect: Joint bar hole cracks can only be seen if the bars are removed or if the crack permeates beyond the joint bar. Where rail is welded, there will not be that many joint bars except in turnouts or in power or signal block areas where insulated joint may be involved. Joint bar inspection must include the bolts themselves to determine whether they have cracked and fallen off. Torqueing bolts too tight may overstrain the bolts, leading to crack failures. Loose joint bars can be easily detected through visual inspection and by tapping with a hammer.

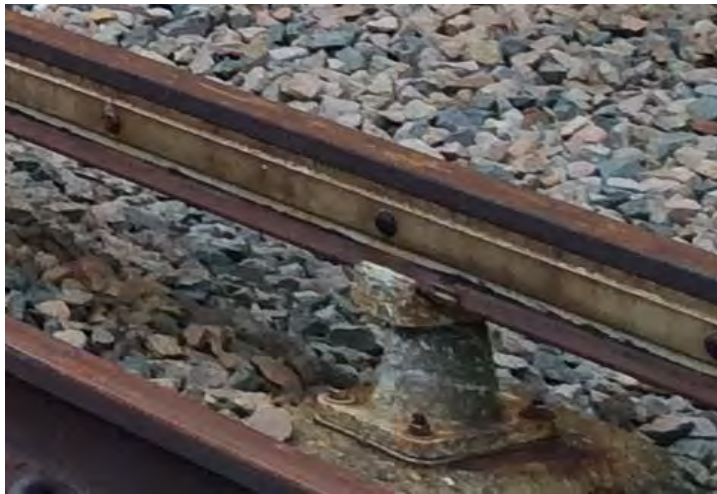
Figure 6.6.3-7 Track Asset Deficiency: Cable

- Loose joint bolt and nut connections
- Loose or detached third rail anchor
- Dirty or broken insulators

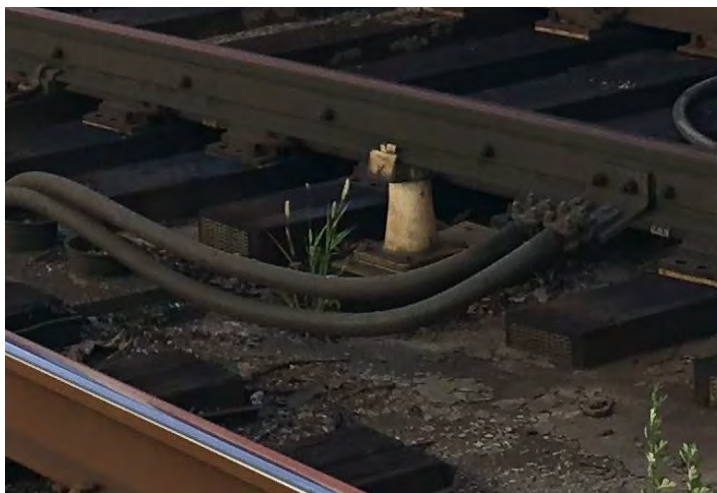
Figure 6.6.3-8 Track Asset Deficiency: Cable

- Disconnected cables from third rail tabs

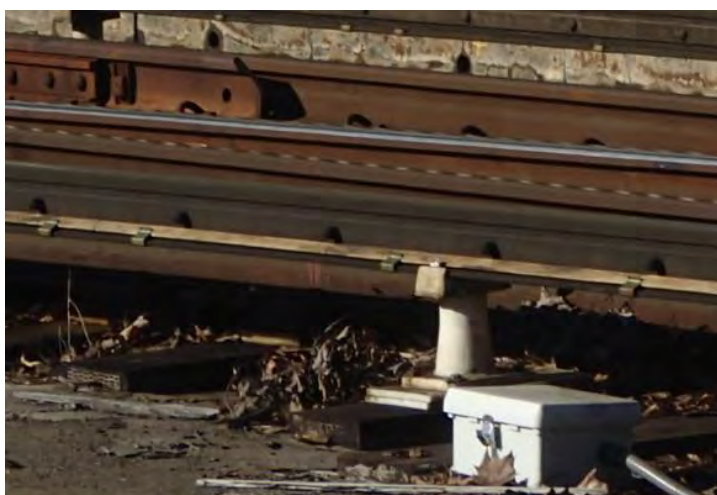
Figure 6.6.3-9 Track Asset Deficiency: Cable

- Detached or loose heater rods

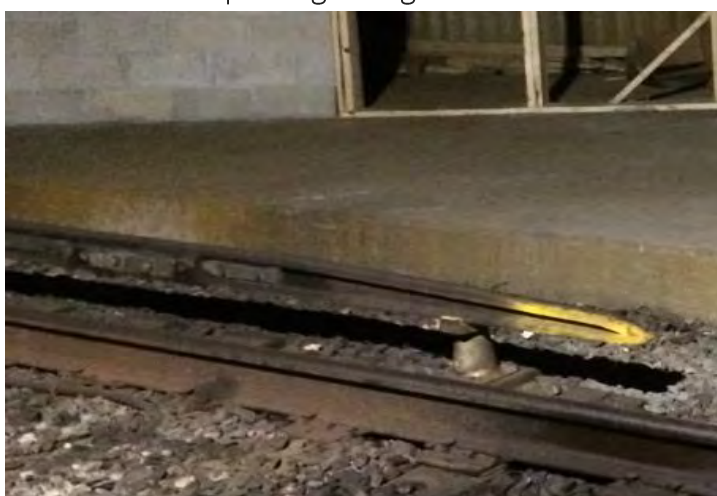
Figure 6.6.3-10 Track Asset Deficiency: Cable

- Risers or run-offs pointing too high or low

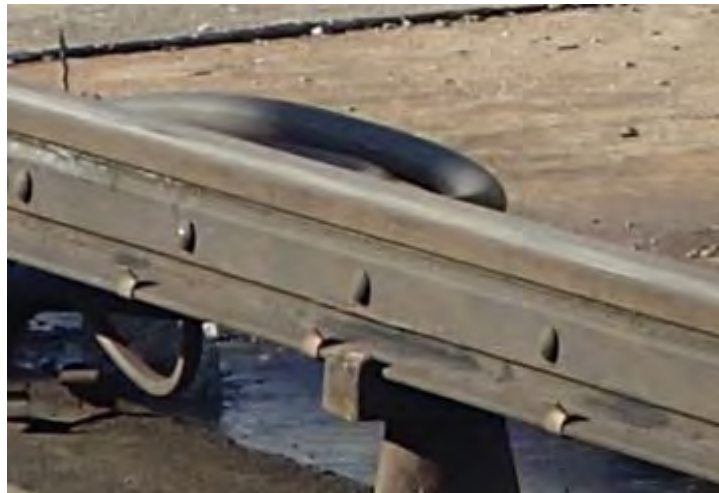
Figure 6.6.3-11 Track Asset Deficiency: Cable

- Cracked rail, excessive pitting, and gauge with running rail; see the photo below of a typical running rail

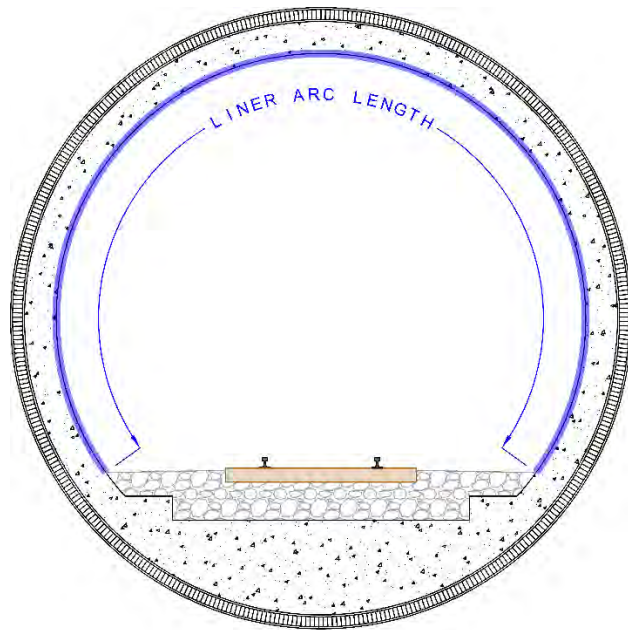
Figure 7.3.4-2 Element Qty Boundary: Liner (SF - Circular & Arch)

Liner (continued)

TUNNEL CROSS SECTION
